Bridge of the Month 127. July 2021 Water Lane, Pontefract

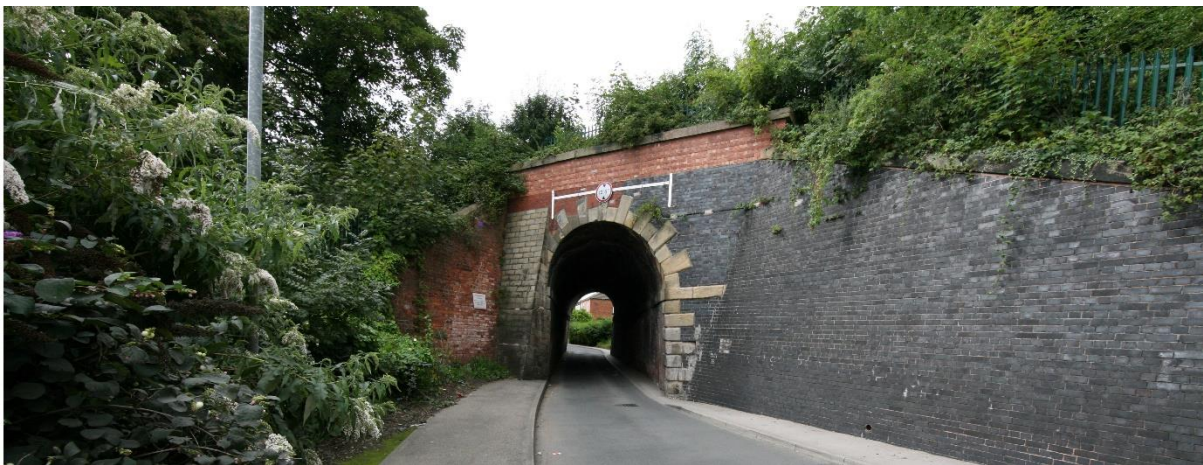
It is a tiny bridge and the skew would make little difference if it were not for the height, and lack of support, of the abutments on the acute corners.

First though, the location, which is [here](#). If you follow that link you will see that the two tracks occupy about a third of the width, which means there is quite a substantial embankment on top and that extended parapet/spandrel shows that the earth has been flowing towards the edges (and, no doubt, being replenished from the top).

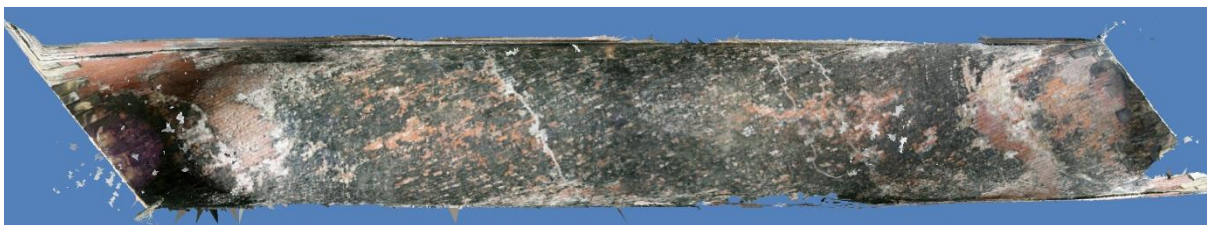
Notice how the cracks are all pretty much along the skew line. I imagine that the ones near mid width are actually a result of the whole thing sagging under the rather greater dead load at mid width. I have seen such cracks in a number of other bridges.

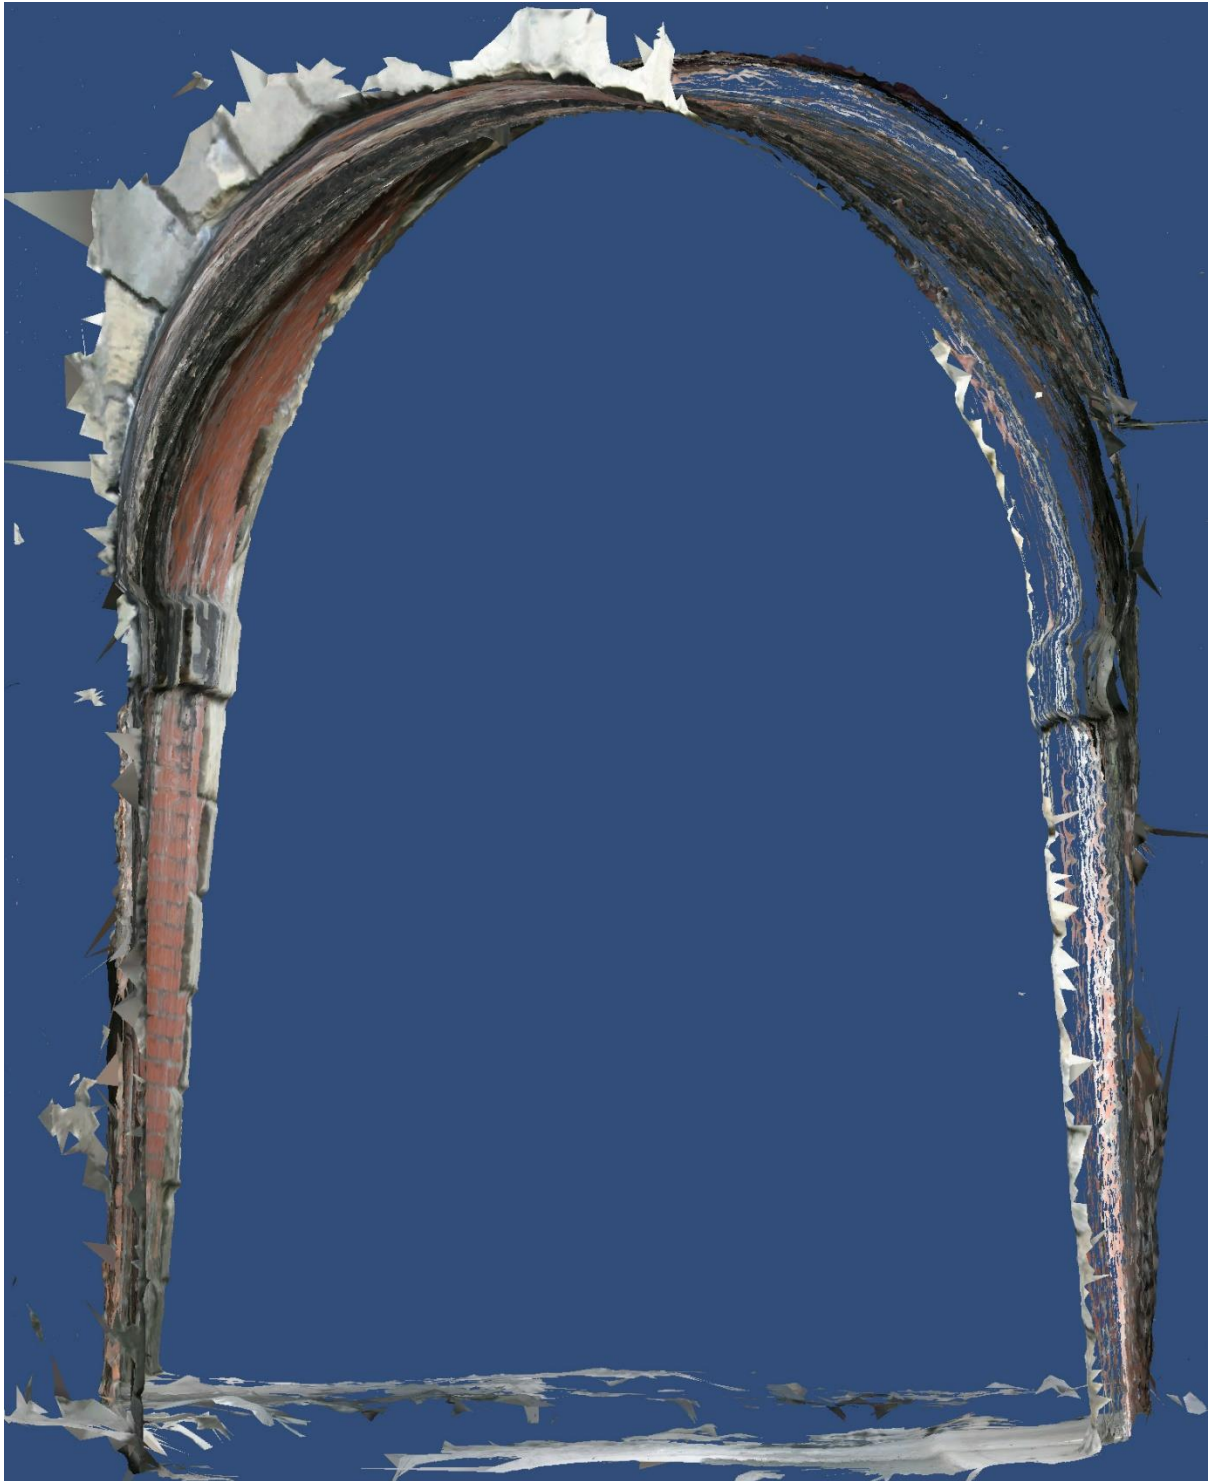
That shape is a bit weird. At the right, we are essentially looking at the back of the abutment. To the left we look straight along the string course which sweeps forward and down towards the end. At the arch crown you can see the sag mentioned above. Looking from the other end the pattern is similar.

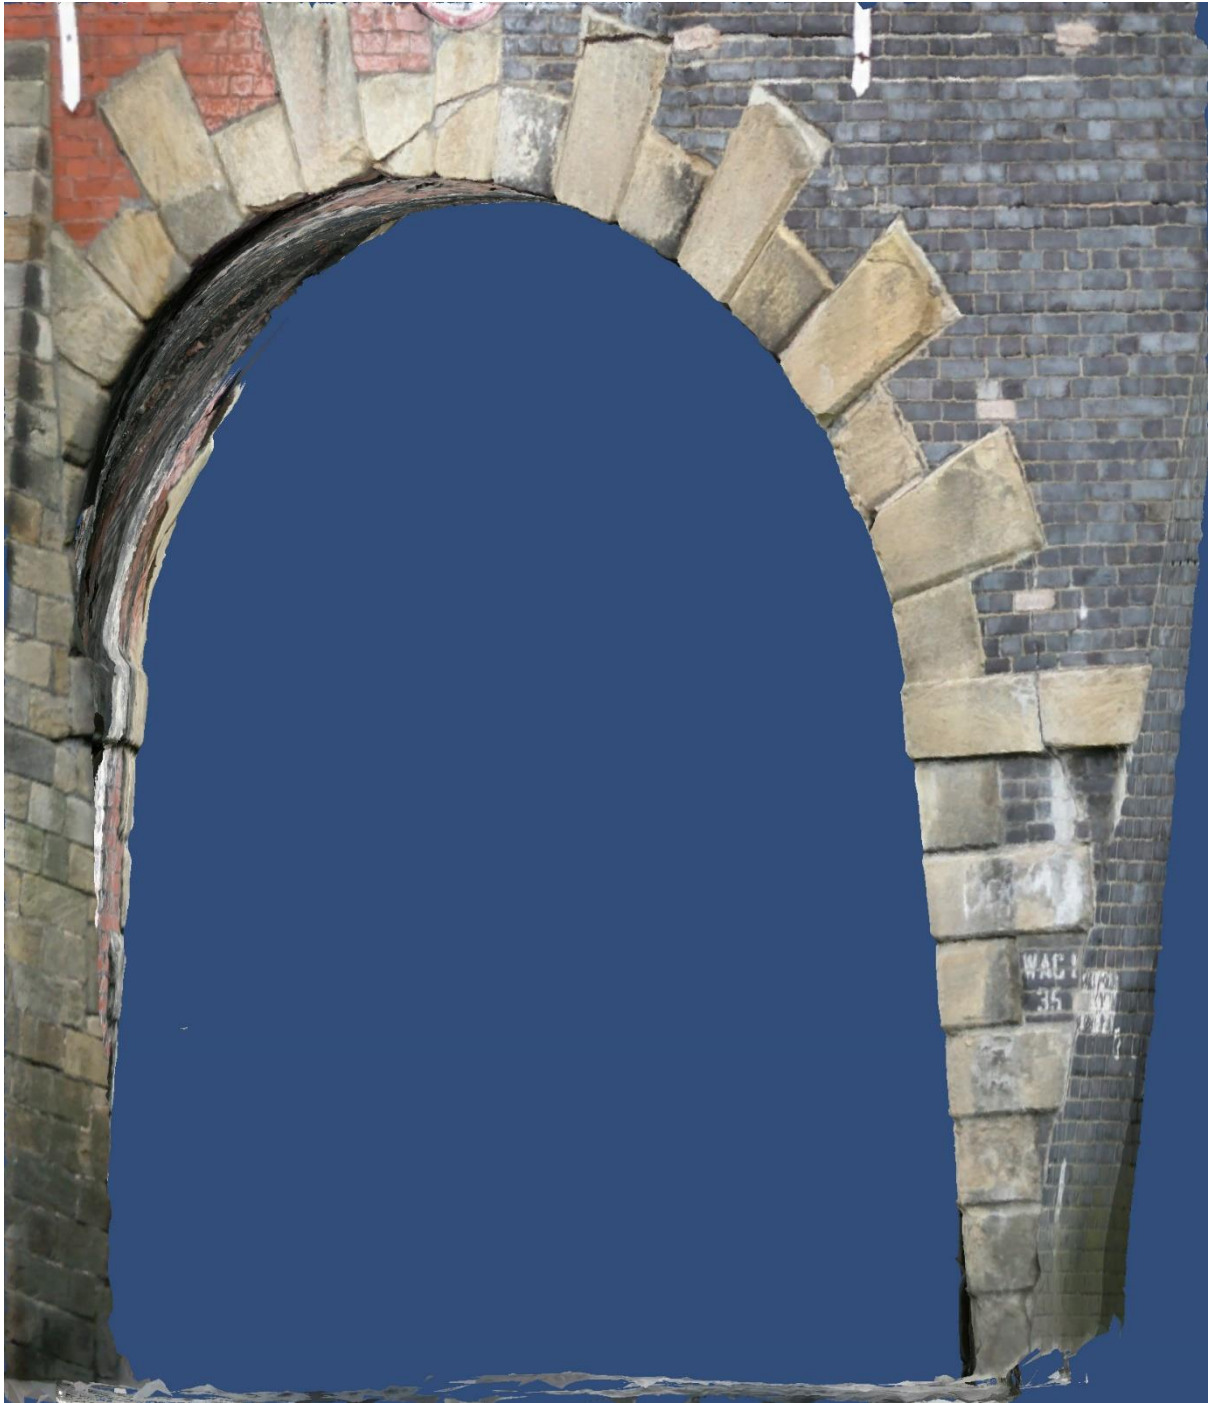
Here we also see the full elevation and the distress in the spandrel walls and the end of the arch itself.

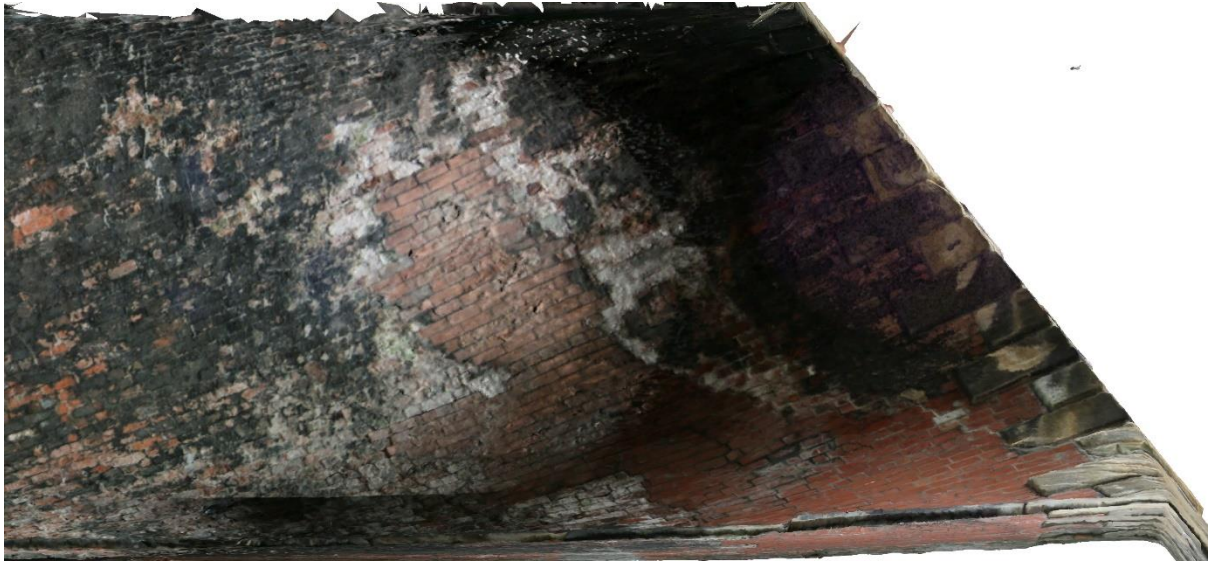
Enlarging the upward view locally shows us a little more of what is going on here. There is quite a lot of newish brickwork and some complex cracking.

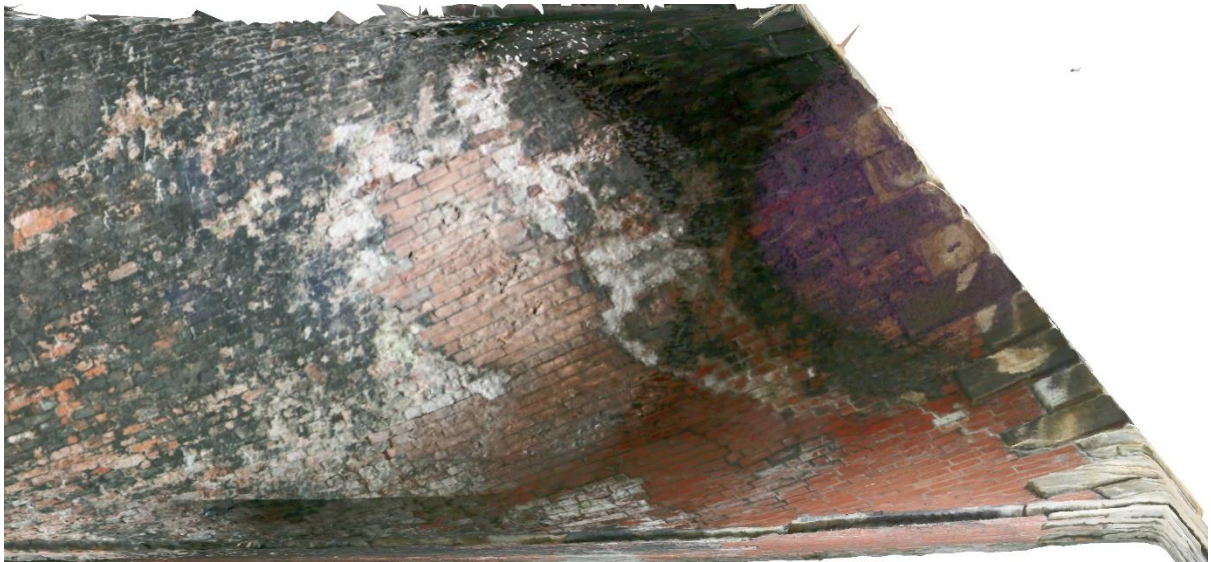
If I push that pic a bit we can see just a little more detail. If I ever get a chance to go back I will use a better camera and, particularly at the end here, capture a few more pictures.

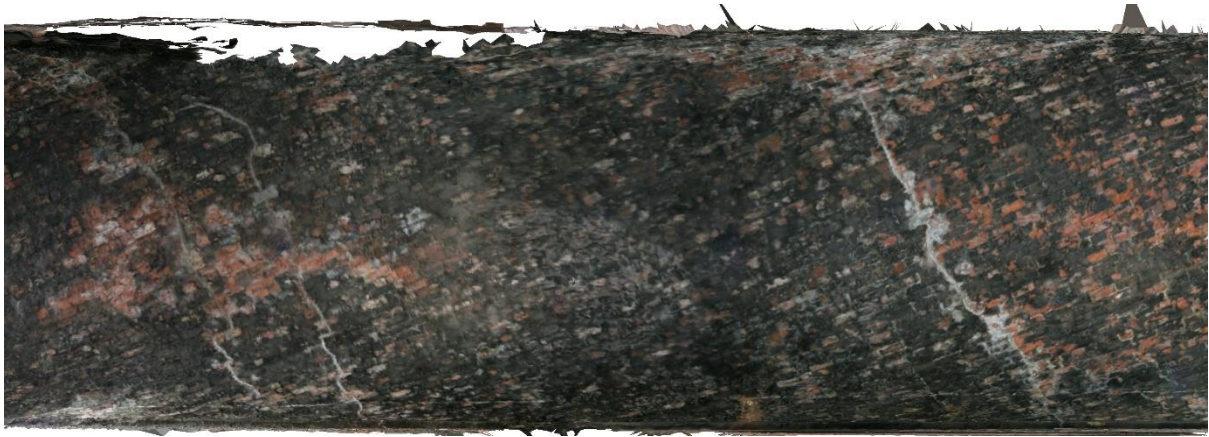
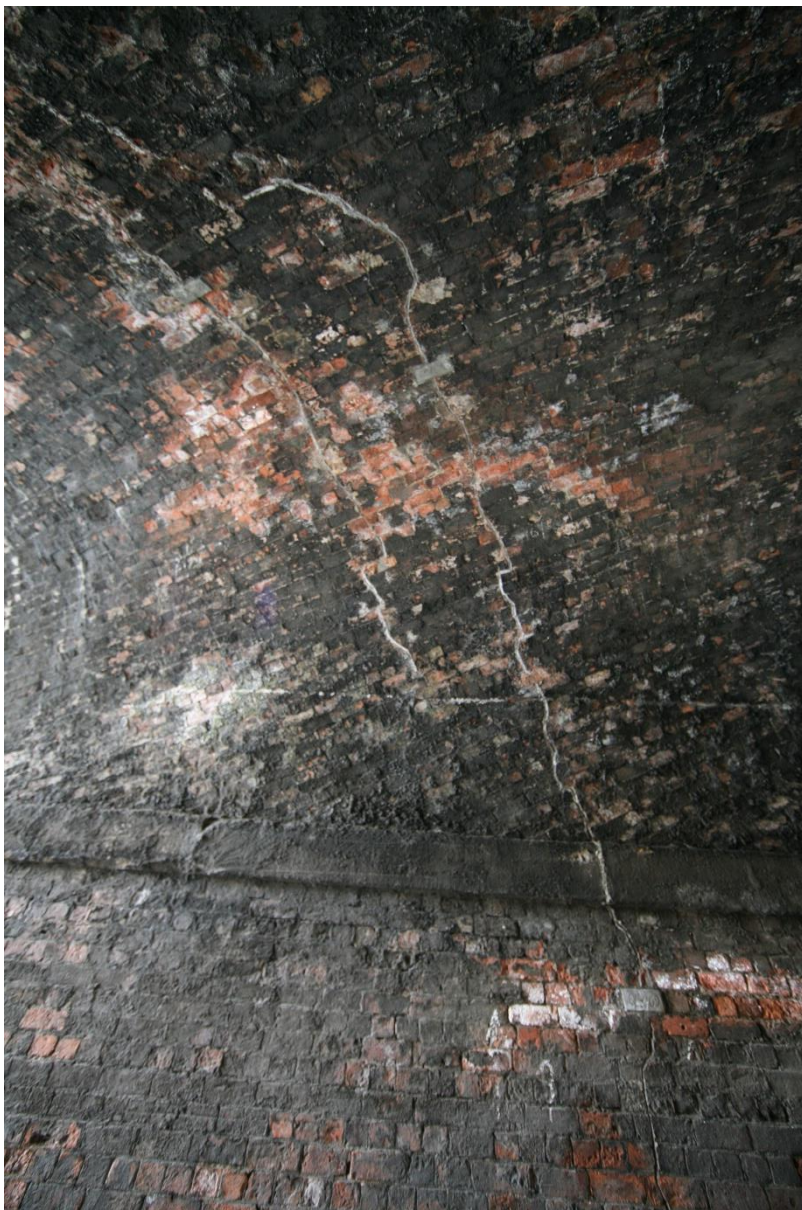
The mid width cracks are also worth a closer look.

The original photos here are better than the model (that wouldn't happen today). The cracks run down into the abutment.

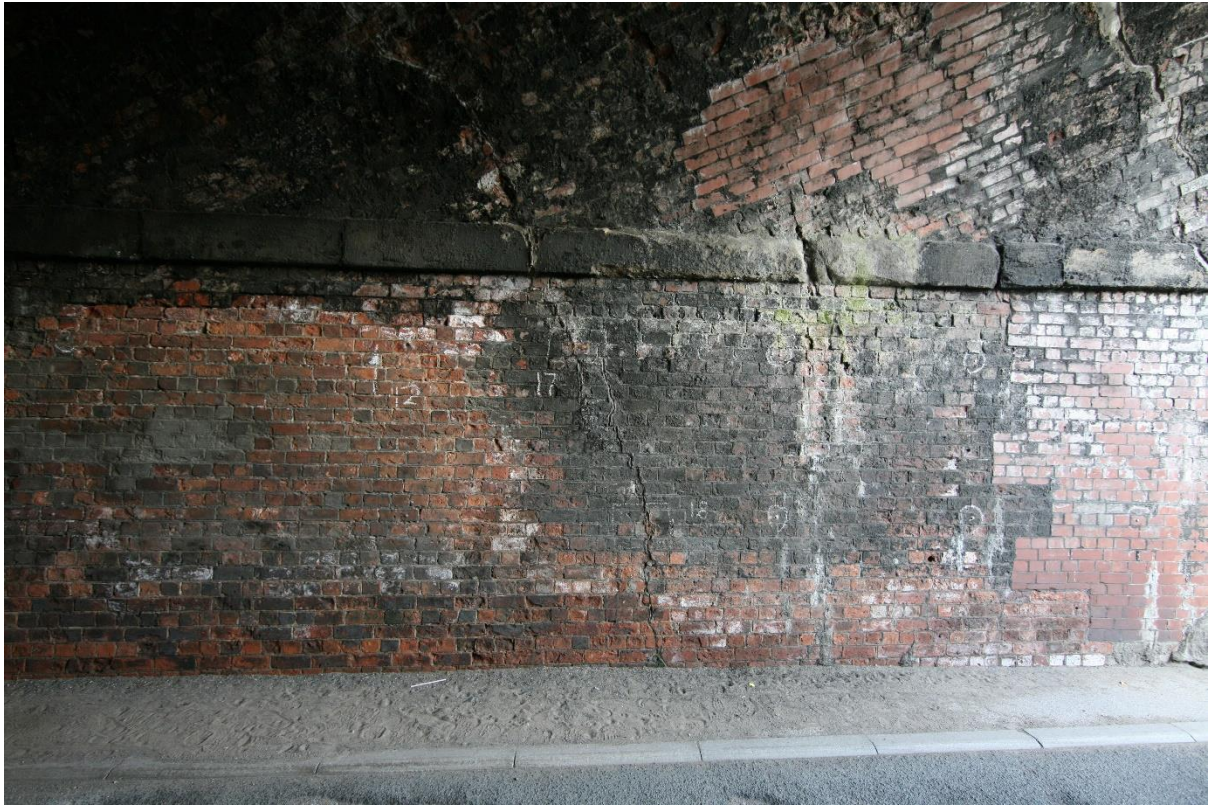
When we look down there we see cracks extending right to the ground and getting (ever so slightly) wider as they go.

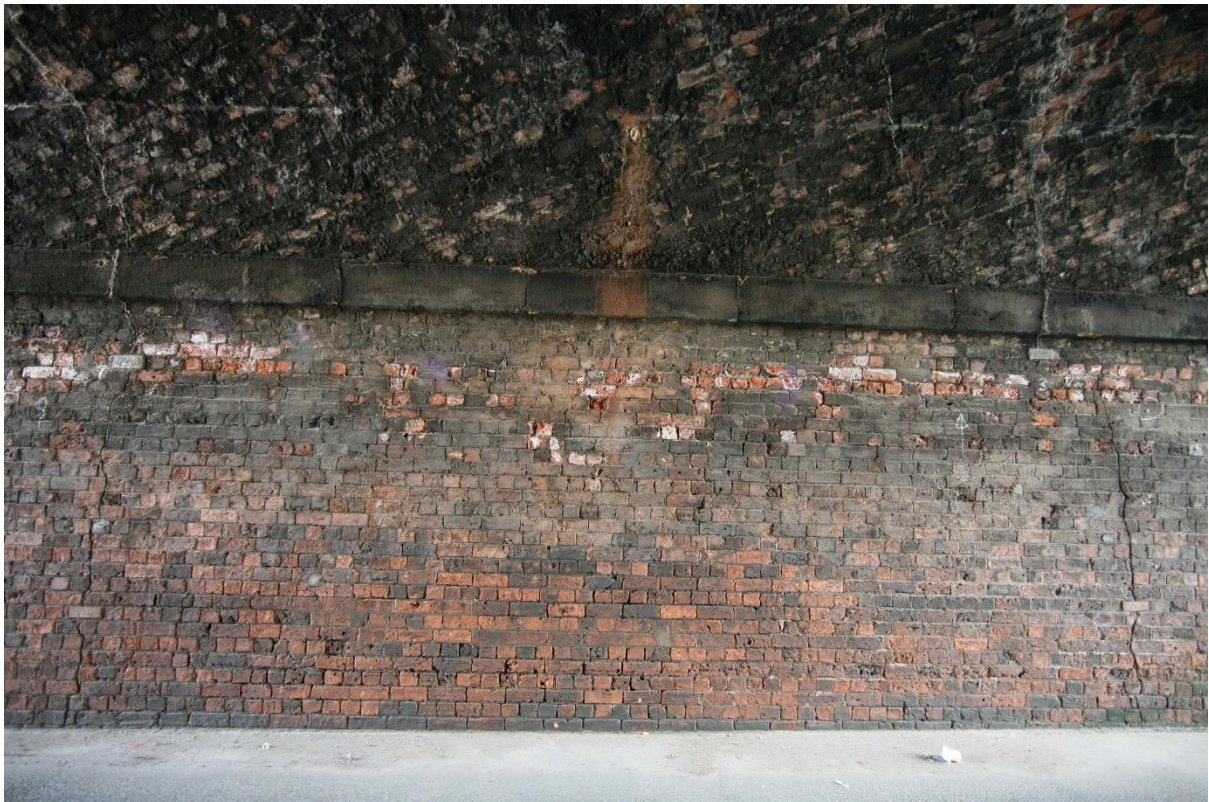
With a similar picture on the opposite wall.

If we cut the arch with a horizontal plane to create a contour we see, as we did from a different direction further up, that the whole bridge has a sag towards the middle.

That is almost certainly caused by the weight of the embankment above and relatively soft ground below. Perhaps the Water Lane name is a clue?

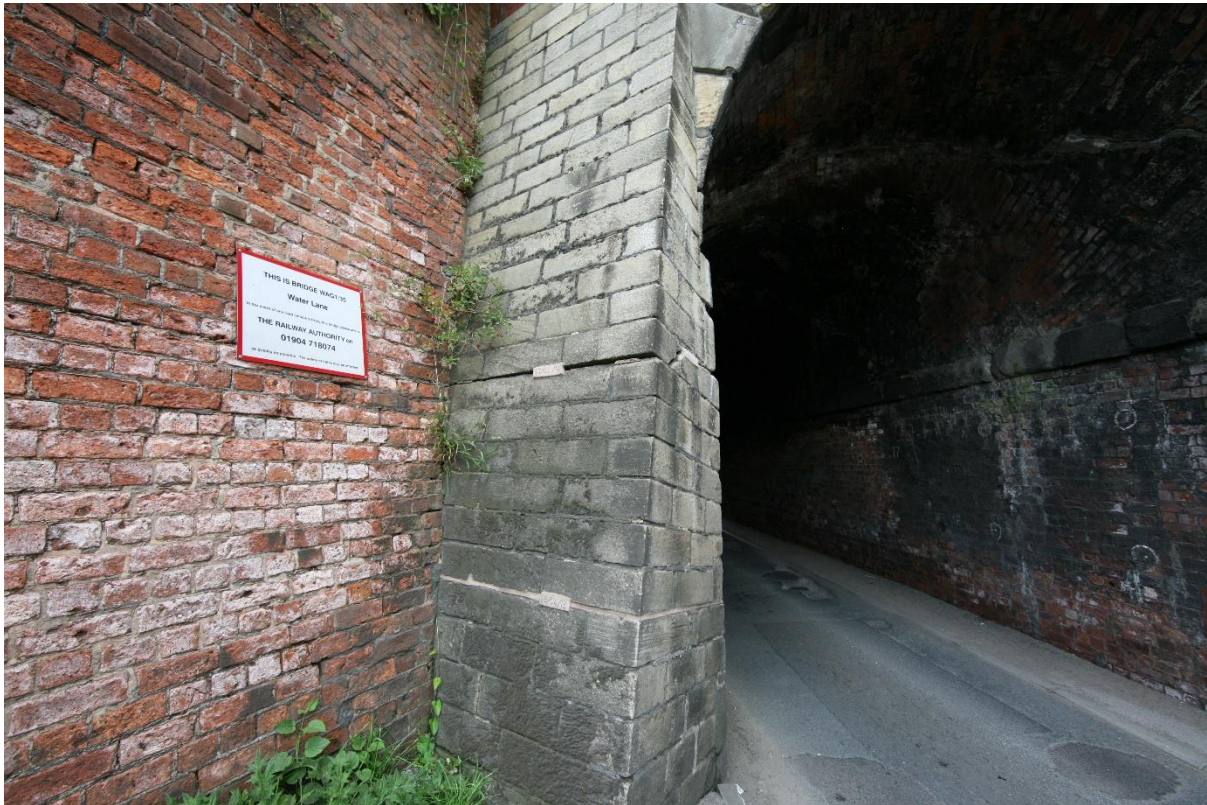
At the portal, against the obtuse corner, a buttress has been added in the vain hope of containing the movement there. The top of the wall is being pushed back into the fill, creating cracks which get noticeably wider to the front over a remarkably short distance. It would be interesting to see what the original wall looks like behind the buttress.

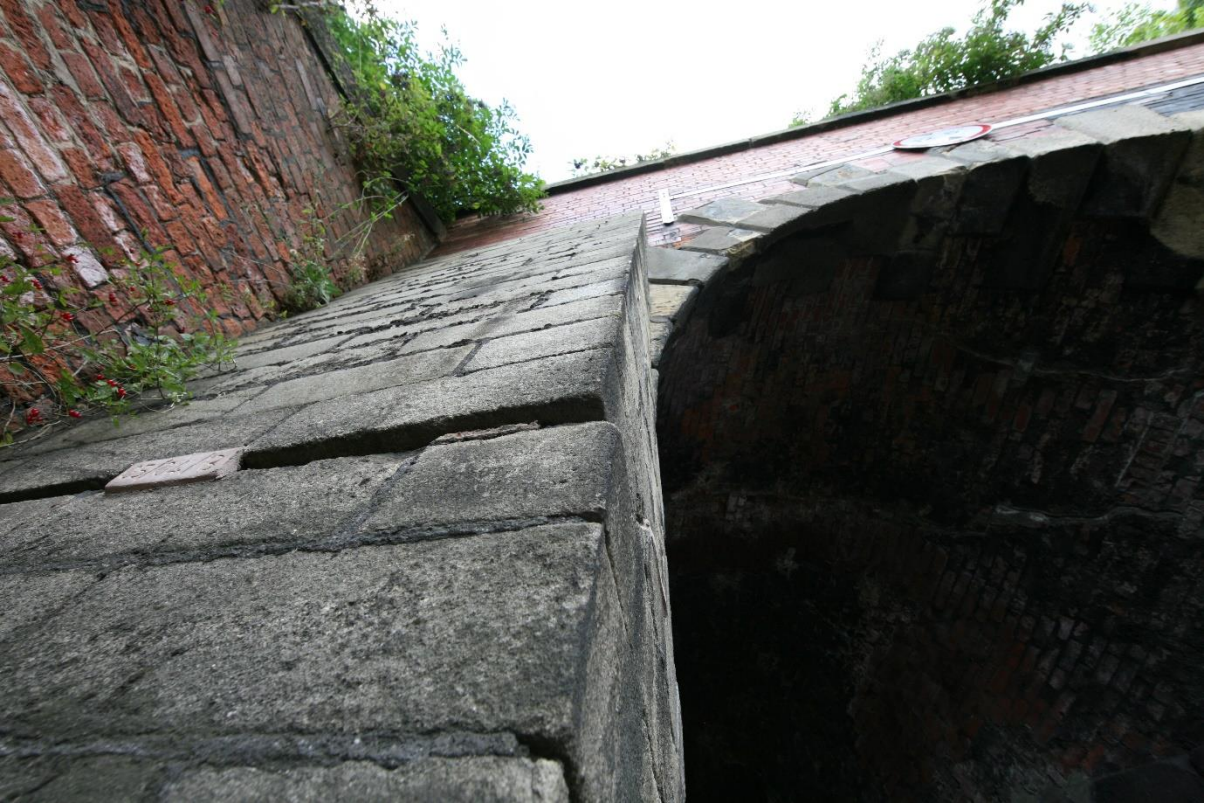
That's quite a joggle in the joint too.

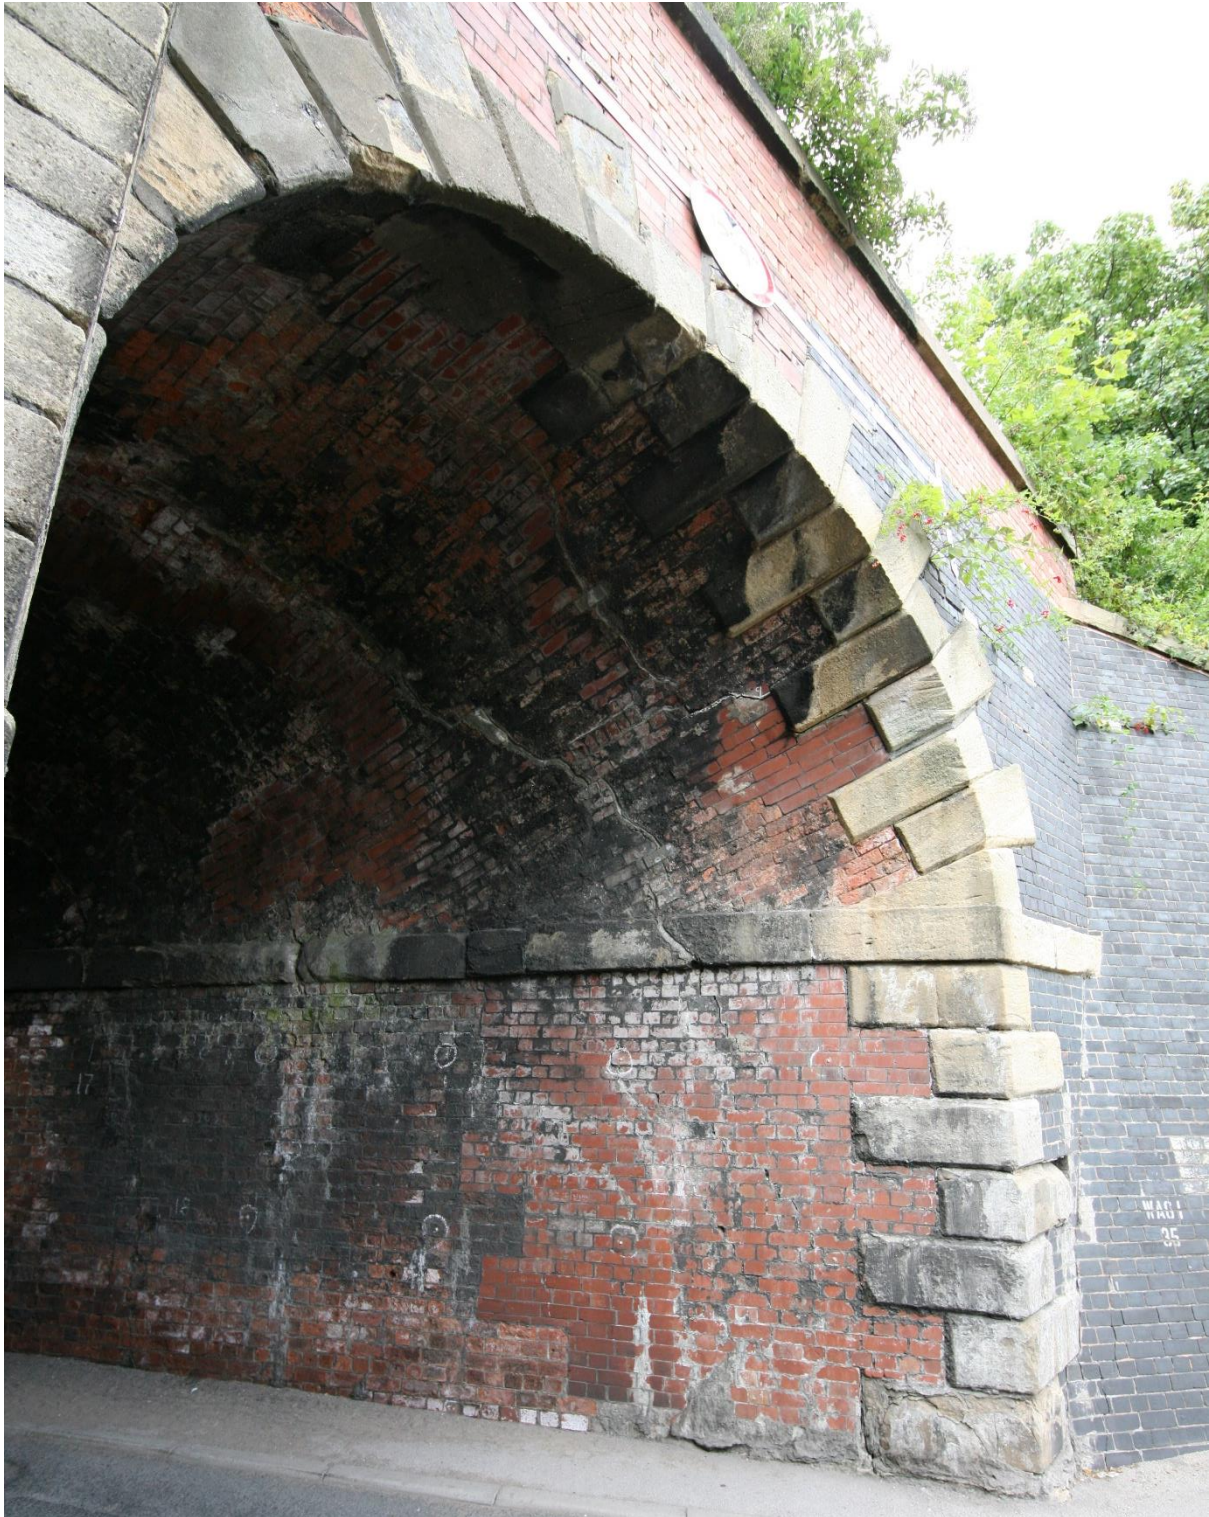
There is red brick patching in both portals. Less here than at the other end below. The cracking is quite a feature though, with cracks right through the stone string course and some step displacement too.

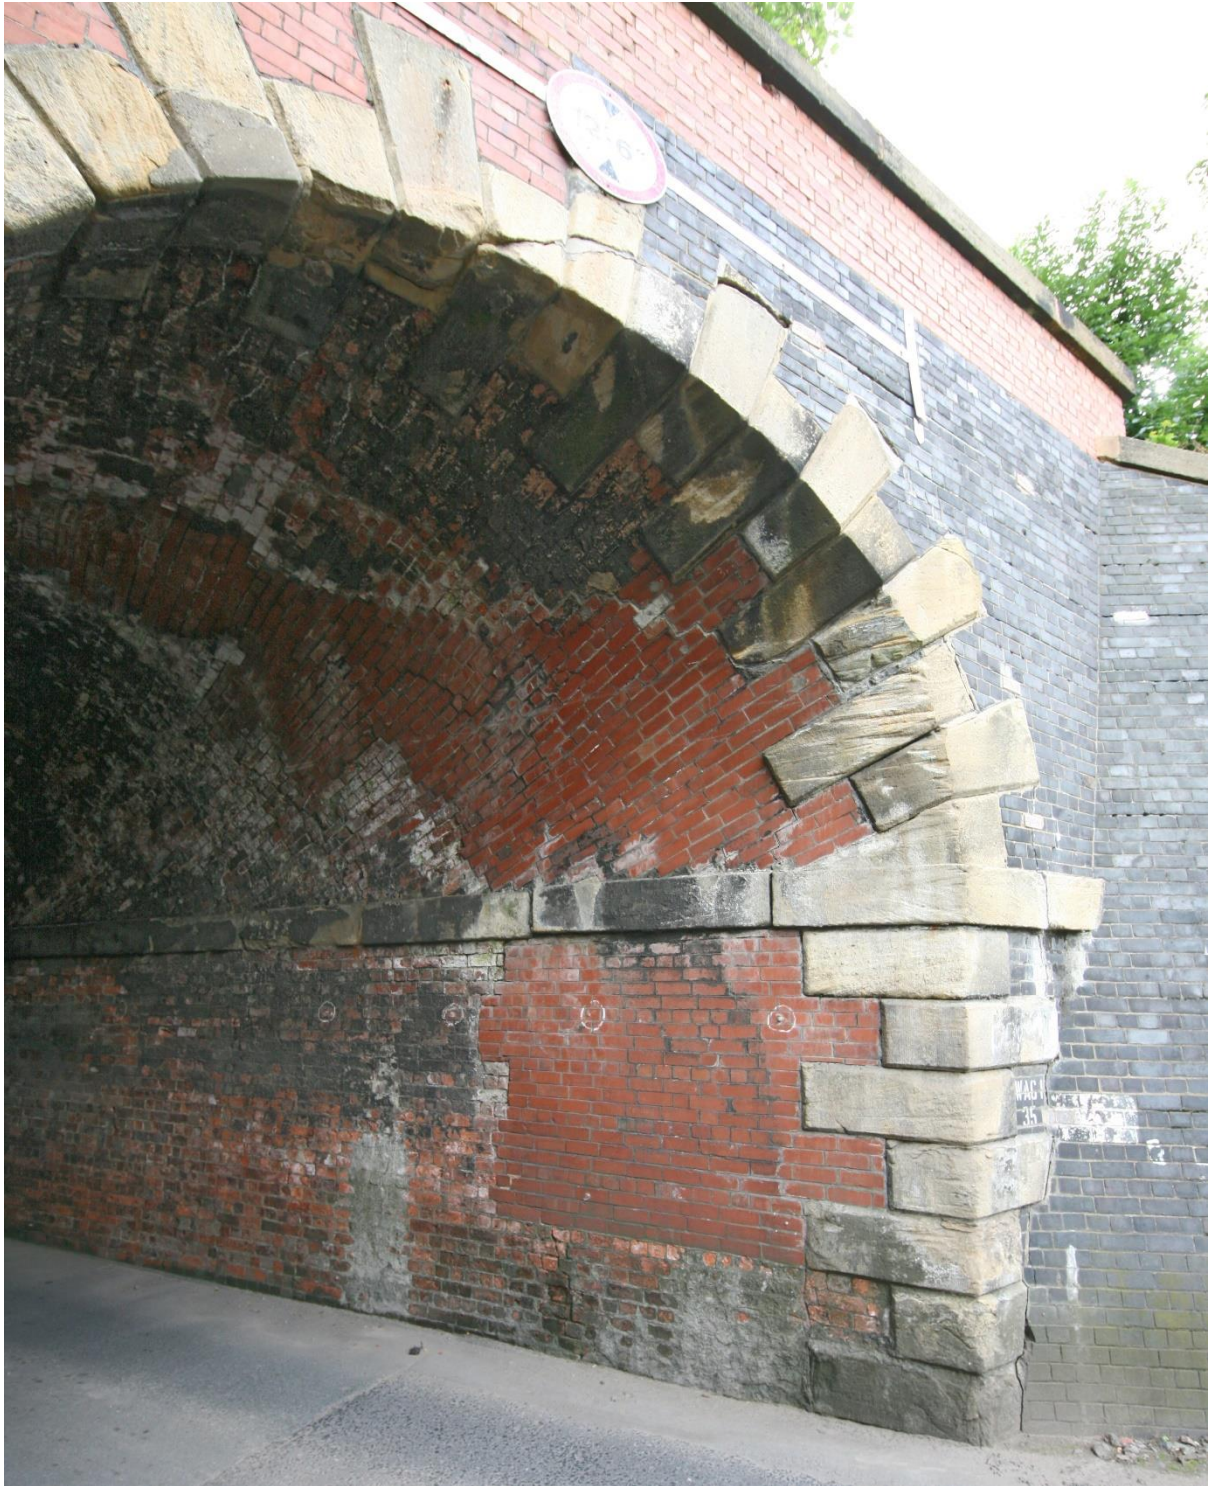
The angle here is slightly better showing the horizontal cracks in the spandrel wall as it is pushed in from the right. It runs down through the arch where it meets serious resistance from the other side, taking the line of weakest resistance.

I suspect that the patching is only skin deep and is therefore cracking through.

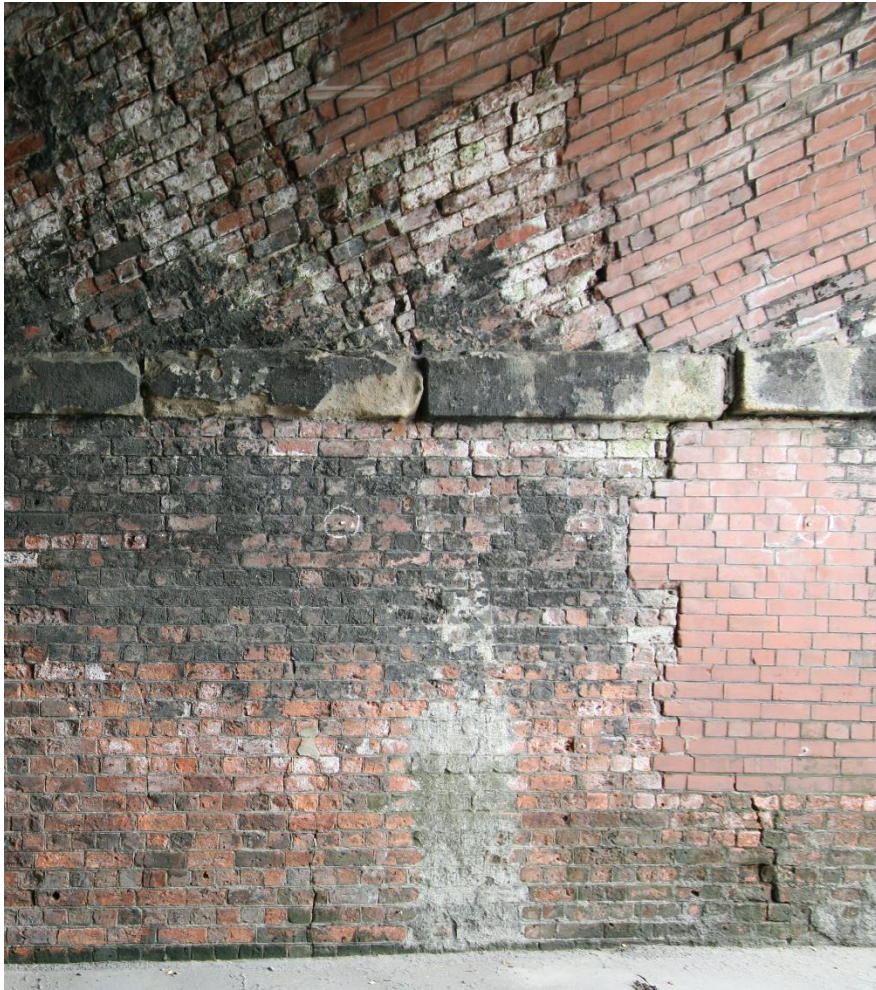
Looking back from inside, with shadows emphasising the steps, the extent and nature of what is going on becomes clearer. Notice the step in the string course at the right, which was surely replicated in the wall below and the arch above before patching. The crack presumably went up the middle of the patch in the wall and somewhere between the two fresh movements in the arch above.

Notice, also, how the beds in the original brickwork at road level dive away into the ground at the right where the forward lean has increased the ground pressure and encouraged settlement.

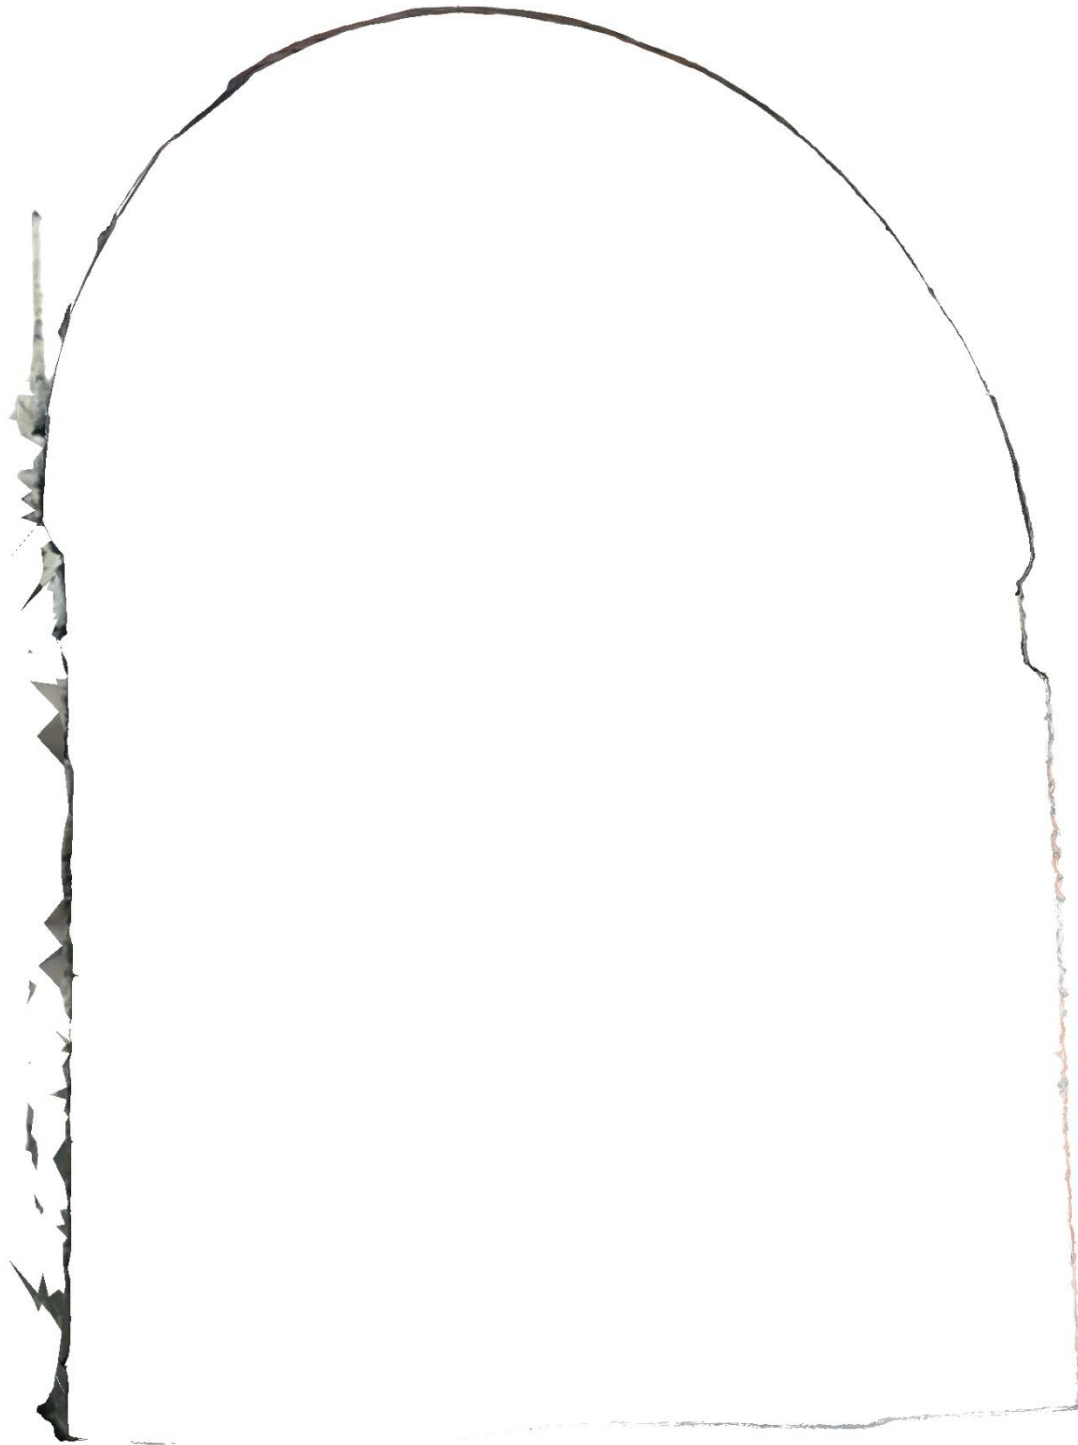
The distortion is shown well in this cross section, though it is worth noting that we had no survey on which to level the model. It is levelled by eye. I suspect this view should be rotated slightly to the left with more of a slope on the right and a definite lean back on the left.

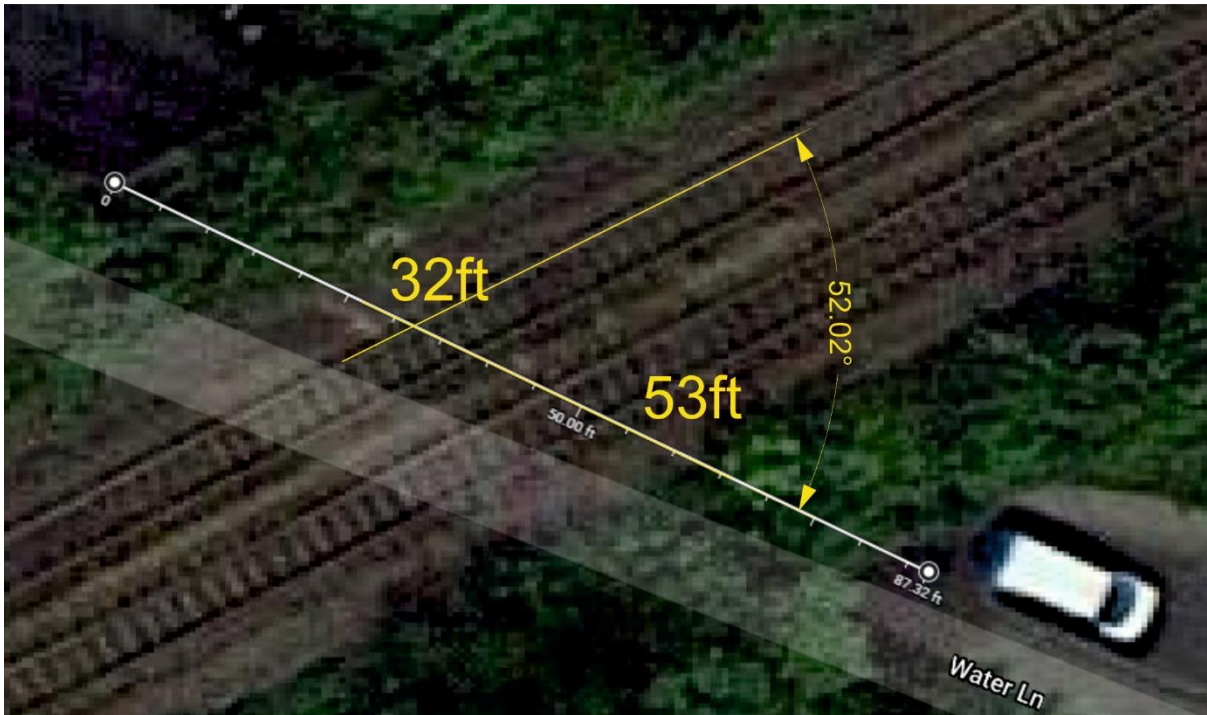
If we look at the layout on Google Maps we can measure the angle of skew and the position of the rails relative to the ends.

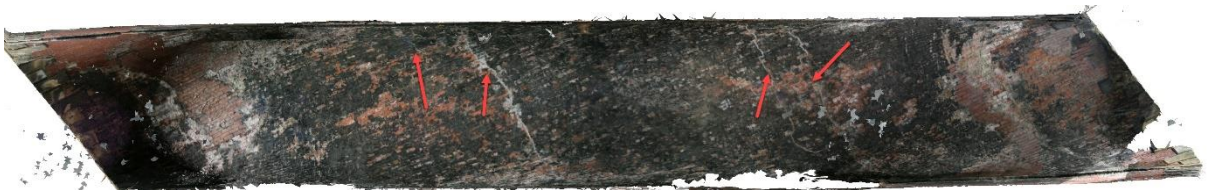
Compare that with the cracks in the roof and I think they tie in closely with the edge of the track.

All that leaves the very difficult question of what might be done. Those acute ends could surely be tied back into the embankment, though doing so without further restricting the very narrow carriageway and footpath would be difficult. I think I would want to do something to be sure that the bottom of the keystone was secure. I expect that the crack rises as it goes in and there is a good anchor in there, but we can't be certain without some sort of invasion. Perhaps a small core upwards near the back of the stone.

So far as monitoring is concerned, I think this might be a place for the old-fashioned invar tapes used by tunnelers. A hook in each wall, a tape with regular perforations to lock to and a dial gauge to finish the detail. To use modern tooling, nothing less than a Metrology instrument would do. Leica have a total station with very high precision. If we only need relative measurements, it will sit on a tripod and measure to a little spherical prism that is moved successively from base to base while the instrument follows.
